SUPERFUND FIVE YEAR REVIEW REPORT

LEE'S LANE LANDFILL

LOUISVILLE, JEFFERSON COUNTY, KY

JUNE 2003

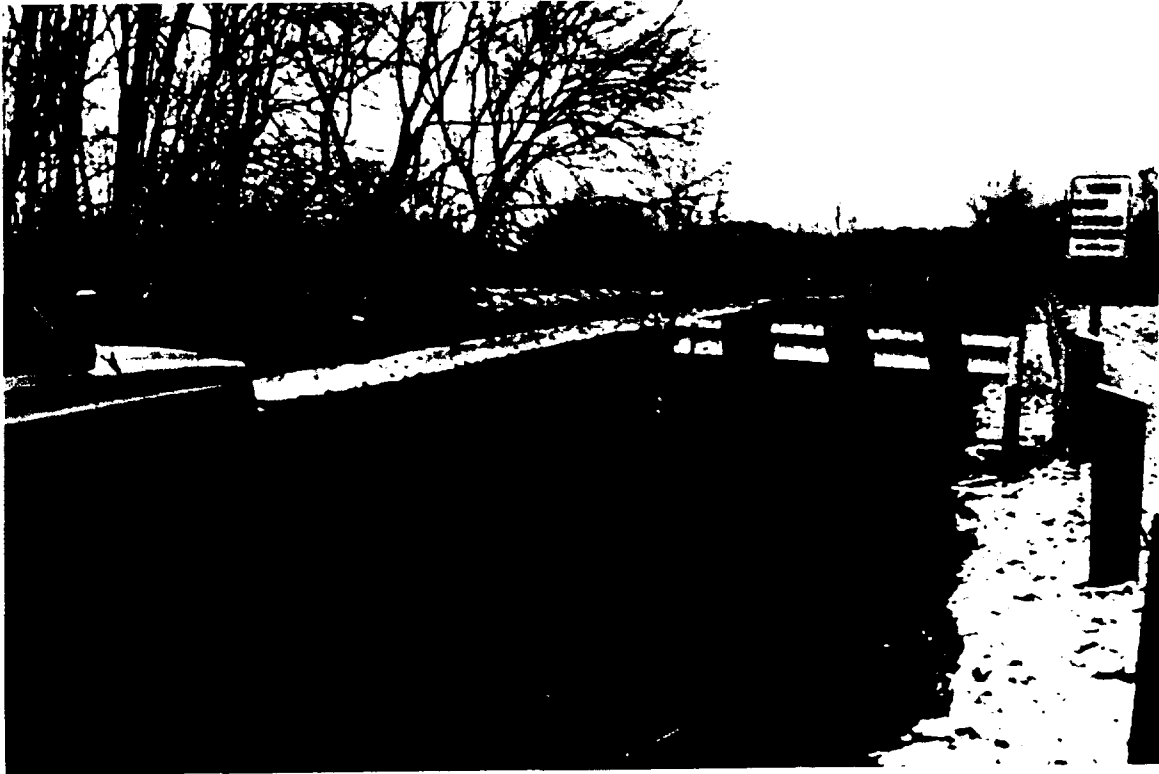
Photograph 1 - Entrance Gate at Lee's Lane

1. The access gate across the Lee's Lane entrance appears to be in good condition. It prevents motor vehicles from entering, but quad-runner ATVs can very easily go around the gates, see Photograph 1 and Figure 4.

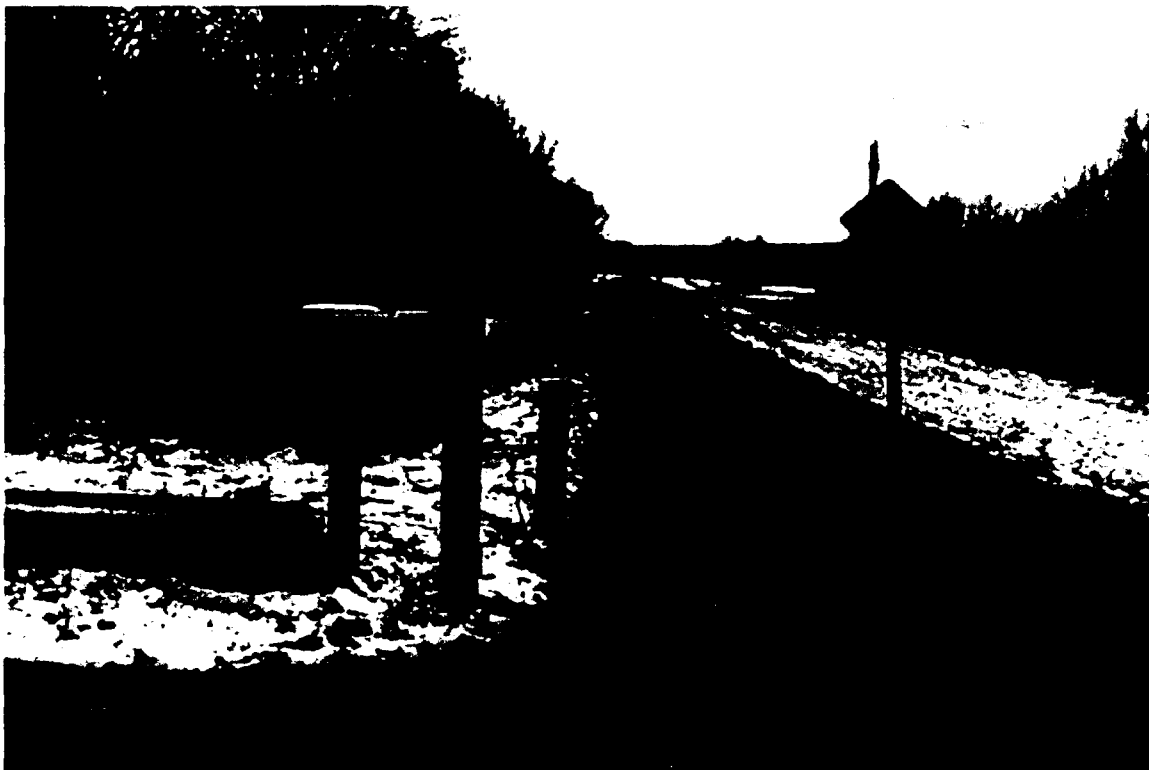
3. Although motor vehicles cannot travel along the asphalt path, pedestrians and quad-runner ATVs can. Cracking of the pavement indicates that it will begin to deteriorate rapidly under heavy traffic, see Photographs 5 and 6.

Photograph 5A - View Looking South Along the Levee from the Lee's Lane Crossing
Note Asphalt Walkout Along Top of Levee
